The Forsmark incident 25th July 2006

An incident occurred at 13.20 on Tuesday 25th July 2006 at Forsmark 1, which was then in operation at full power, 990 MW. The origin of the incident lay in a short circuit in the 400 kV switchyard outside the plant. It resulted in severe voltage fluctuations which, in a complicated manner, spread into several of the electrical systems in the plant.

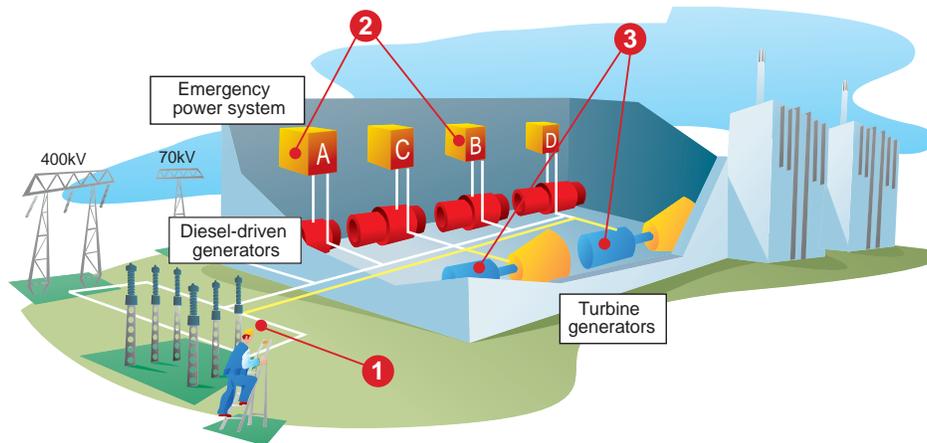
incident were as follows (see diagram above):

1. The initial event – i.e. the short circuit in the 400 kV switchyard, for which Svenska Kraftnät (the owner and operator of the Swedish national grid) is responsible – was due to the fact that work there was not carried out in the correct manner.

2. The short circuit in the switchyard resulted in a more severe disturbance to the electrical systems in the power station than the systems had been designed for.

3. Various electrical components in the power station had been replaced in 2005, but had not been adequately tested after replacement.

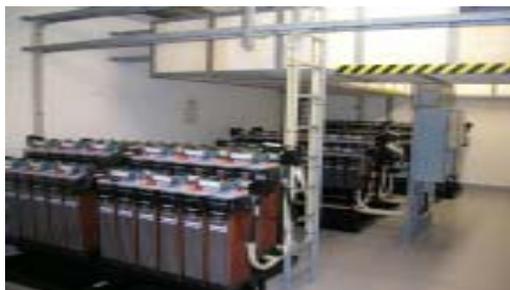
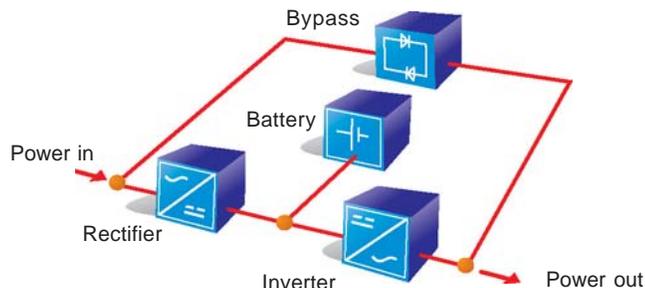
Each of the four subs contains an Uninterruptable Power Supply (UPS) system, as shown below. These are systems which, using batteries, ensure a no break supply of alternating current to important safety systems.

For the UPS systems in two subs, A and B, the overvoltage resulted in failure of the units and loss of the 220 V supply. Subs C and D withstood the voltage variations and continued to operate, which meant that equipment supplied from them operated as intended.

The various integral component protection systems in the rectifiers and inverters caused two of the four UPS systems to be knocked out.

The UPS systems are intended to supply the low voltage AC systems with battery backed no break power during and after a fault, for a period of at least two hours. During normal operation, the batteries in each UPS are float charged from the normal AC system via rectifiers. In the event of loss of power supply, the batteries supply the safety equipment powered from the system with low voltage AC via inverters. Both the rectifiers and the inverters incorporate various internal component protection features.

The battery backed no break AC system is intended to supply equipment that is essential for safe shutdown of the reactor. However, in fact, this incident resulted in a loss of power from the UPS system on subs A and B.

The UPS systems were installed at Forsmark 1 and 2 over ten years ago, with trip and protection settings for the systems and components as recommended by the supplier. They replaced equipment based on mechanical technology, which was more resistant to electrical disturbances.

Tests that were carried out after the incident by the supplier of the UPS systems showed that the overvoltage protection operated as expected with voltage variations in the range 85-110 % of nominal value.

However, the voltage variation that actually occurred was much greater, and so it was to be expected that the UPS systems could not deal with it.
