The Forsmark incident 25th July 2006

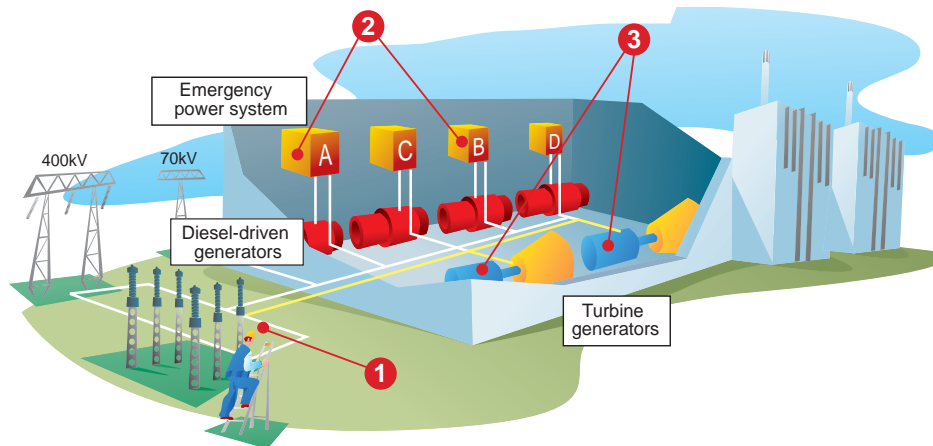
1. The initial event – i.e. the short circuit in the 400 kV switchyard, for which Svenska Kraftnät (the owner and operator of the Swedish national grid) is responsible – was due to the fact that work there was not carried out in the correct manner.

2. The short circuit in the switchyard resulted in a more severe disturbance to the electrical systems in the power station than the systems had been designed for.

3. Various electrical components in the power station had been replaced in 2005, but had not been adequately tested after replacement.

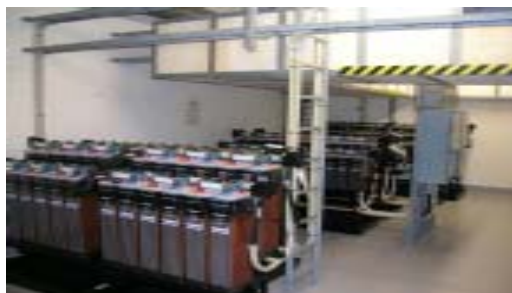
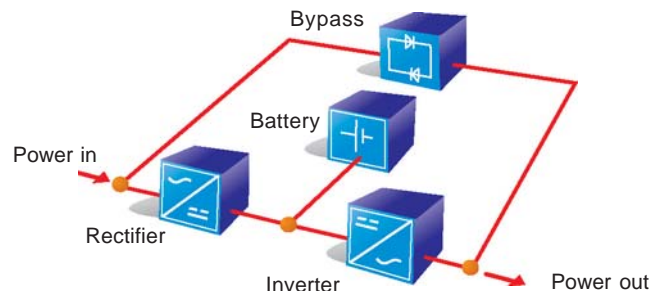
Each of the four subs contains an Uninterruptable Power Supply (UPS) system, as shown below. These are systems which, using batteries, ensure a no break supply of alternating current to important safety systems.

For the UPS systems in two subs, A and B, the overvoltage resulted in failure of the units and loss of the 220 V supply. Subs C and D withstood the voltage variations and continued to operate, which meant that equipment supplied from them operated as intended.

The various integral component protection systems in the rectifiers and inverters caused two of the four UPS systems to be knocked out.

The UPS systems are intended to supply the low voltage AC systems with battery backed no break power during and after a fault, for a period of at least two hours. During normal operation, the batteries in each UPS are float charged from the normal AC system via rectifiers. In the event of loss of power supply, the batteries supply the safety equipment powered from the system with low voltage AC via inverters. Both the rectifiers and the inverters incorporate various internal component protection features.

The battery backed no break AC system is intended to supply equipment that is essential for safe shutdown of the reactor. However, in fact, this incident resulted in a loss of power from the UPS system on subs A and B.

The UPS systems were installed at Forsmark 1 and 2 over ten years ago, with trip and protection settings for the systems and components as recommended by the supplier. They replaced equipment based on mechanical technology, which was more resistant to electrical disturbances.

Tests that were carried out after the incident by the supplier of the UPS systems showed that the overvoltage protection operated as expected with voltage variations in the range 85-110 % of nominal value.

However, the voltage variation that actually occurred was much greater, and so it was to be expected that the UPS systems could not deal with it.
